# Manhole Inspection Summary

Manhole # S41QQ\_018MH

Insp Date: **4/4/07 8:22 AM**

**Location** Address: **900 25TH ST**

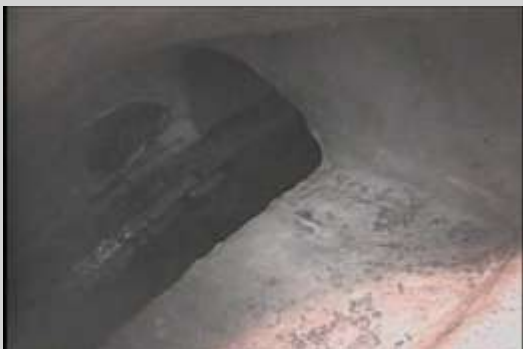
### 24 in. Circular Gravity Sewer Pipe In @ 6 O'Clock

Pipe Material: **PVC** ☐ Pipe Lined

Invert Depth: **19.89** (ft.) Flow Characteristics: **Fast**

Infiltration: **None** Pipe Seal Cond: **Unknown**

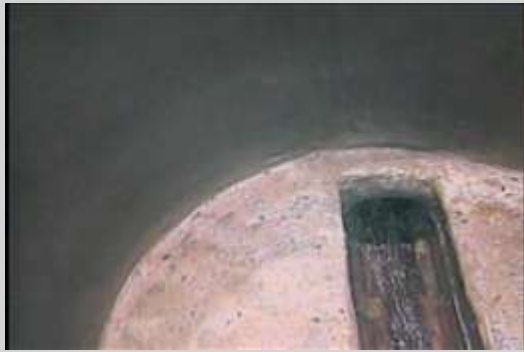
Pipe In @ 9 O'Clock

Pipe Material: **Clay**

Infiltration: **None**
